NIST NCSTAR 2: Vol. I

Report of the Technical Investigation of The Station Nightclub Fire

June 2005

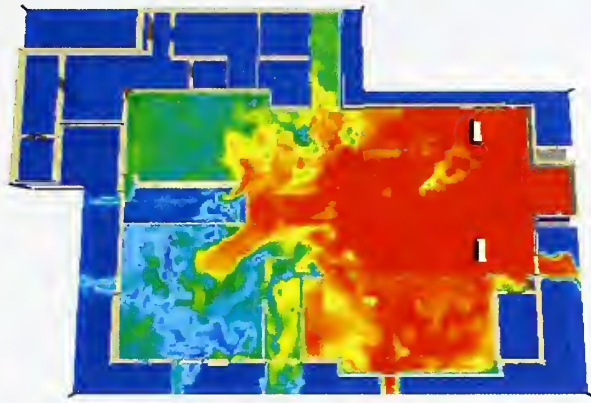
The precise event which led to the crowd-crush likely was related to the arrangement of the single interior door with merging streams of traffic and the pressure to escape the rapidly deteriorating conditions in the main area of the nightclub. Measurements of temperature, heat flux and gas species in a reconstruction of the platform area fire at NIST and computer models of the NIST experiment and the full nightclub suggest that the conditions around the platform, dance floor, sunroom, and dart room would have led to severe incapacitation or death within about 1-1/2 minutes after ignition of the foam for anyone remaining standing, and for not much longer even for those occupants close to the floor.

Temperatures 1.5 m (5 ft) above floor 90 seconds after ignition, calculated from computer simulation of full-scale nightclub fire.

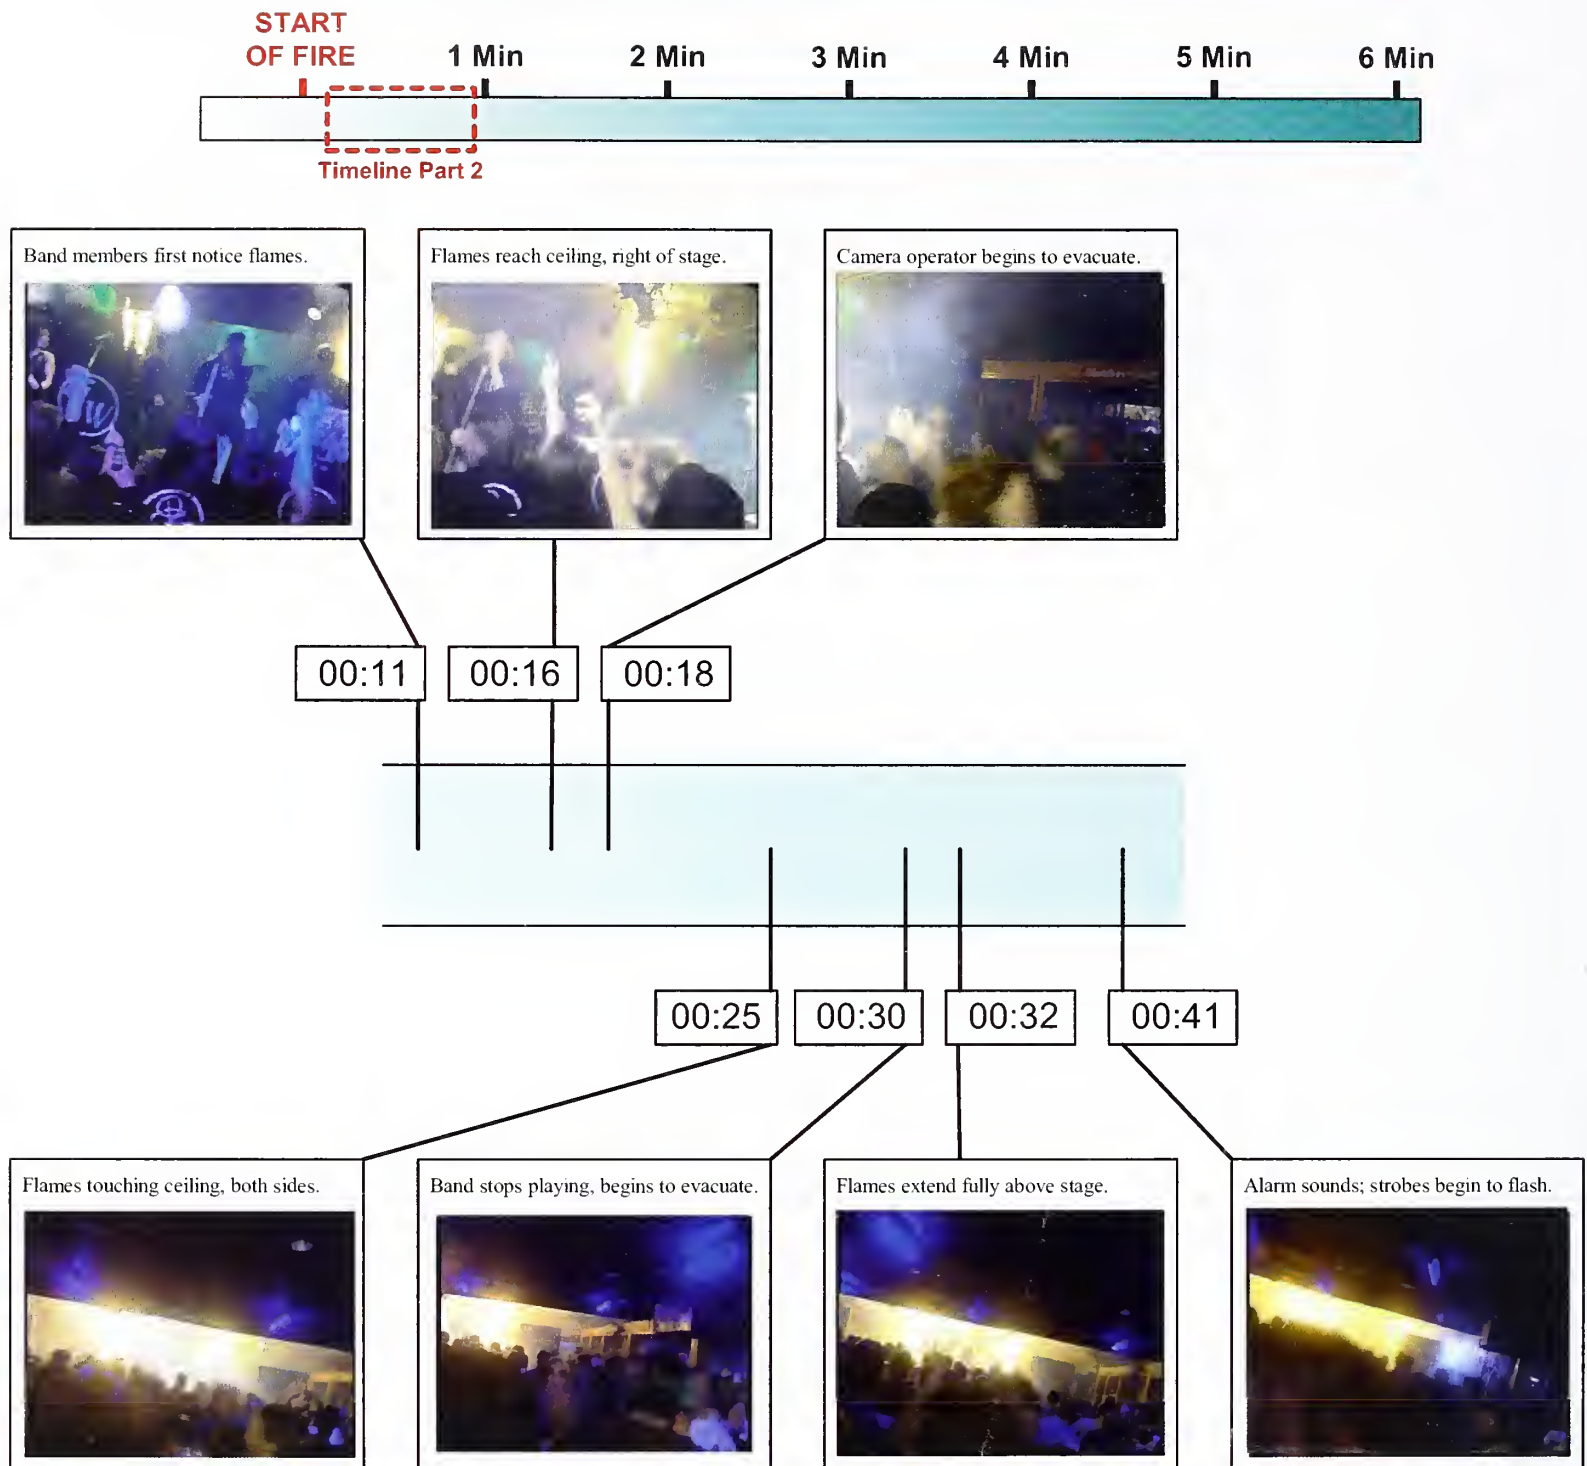
Figure 2-2b. Evacuation Timeline (10 seconds to 50 seconds after ignition). Video stills copyright © 2003 TVL Broadcasting, Inc. All rights reserved.

recognize the fire danger at 24 seconds. Around the time the band stopped playing (30 seconds fire time), the bulk of the crowd had begun the evacuation process. At 41 seconds the fire alarm could be heard and the strobe seen on the video. (See Fig. 2-2b.)

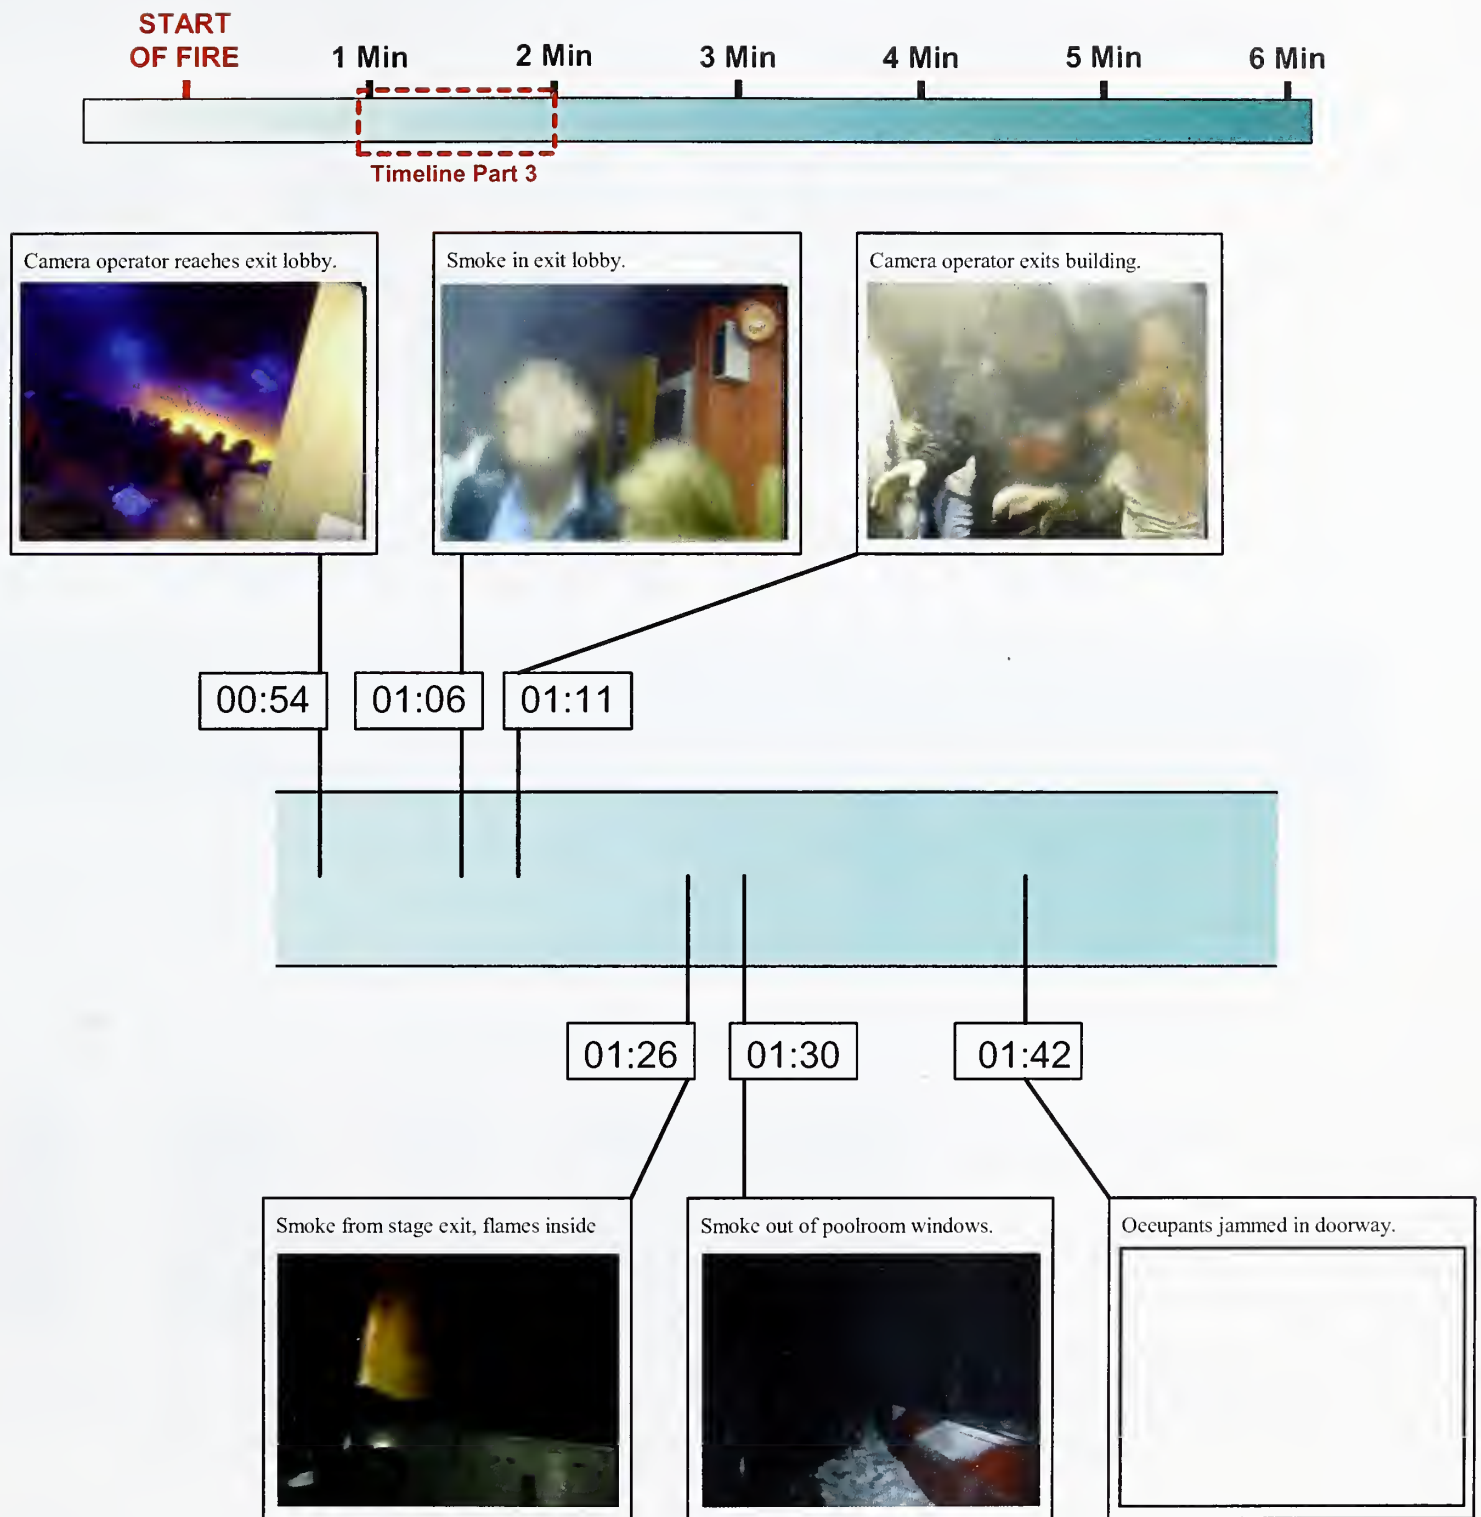
Figure 2-2c. Incident Timeline (50 seconds to 2 minutes after ignition). Video stills copyright © 2003 TVL Broadcasting, Inc. All rights reserved.

The videographer made his way to the exit lobby while continuing to capture the movement of the crowd leaving the area around the dance floor. As seen in Fig. 2-2c, he exited the building at 1 minute 11 seconds (fire time) along with a steady stream of occupants. Sometime estimated to be around 1 minute 30 seconds after ignition of the foam, the front exit became blocked with people, and occupants could be seen breaking windows and escaping from the poolroom/sunroom. The result of the crowd crush at the front exit was captured on the video at 1 minute 42 seconds (Fig. 2-2c). The latest time recorded for an occupant escaping from inside the main bar (through a window) was at 4 minutes 8 seconds; however, people stuck in the front entrance are seen in the video to have escaped as late as 5-1/2 minutes into the fire, just before the fire department ran its first hose line (Fig. 2-2d). (One patron claimed to have been pulled from the bottom of the pile by a firefighter considerably later, but this has not been confirmed by the NIST investigation.)

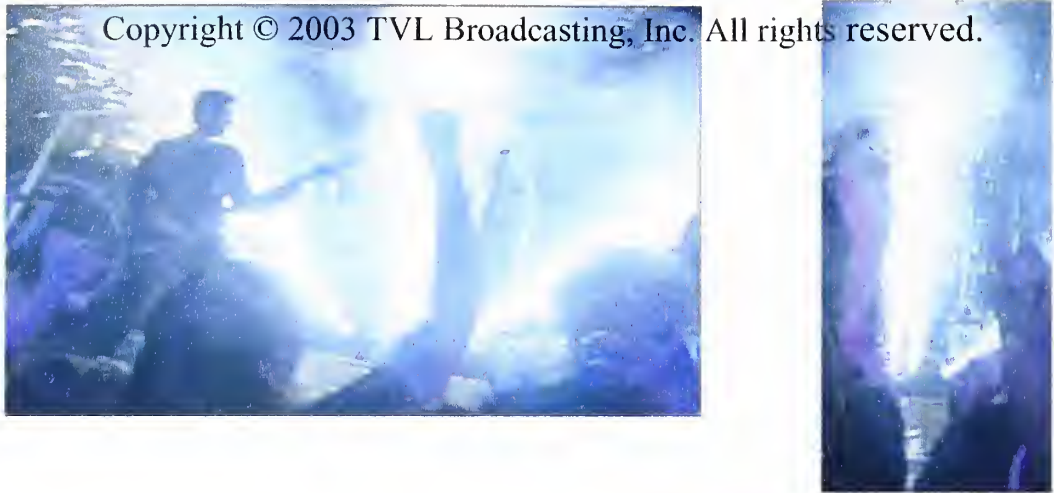
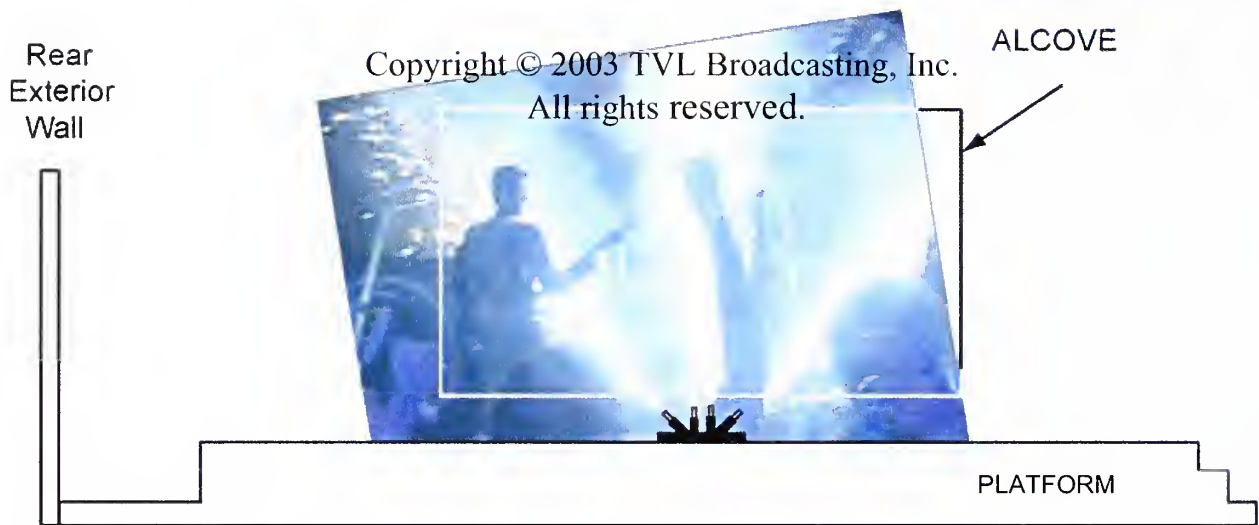
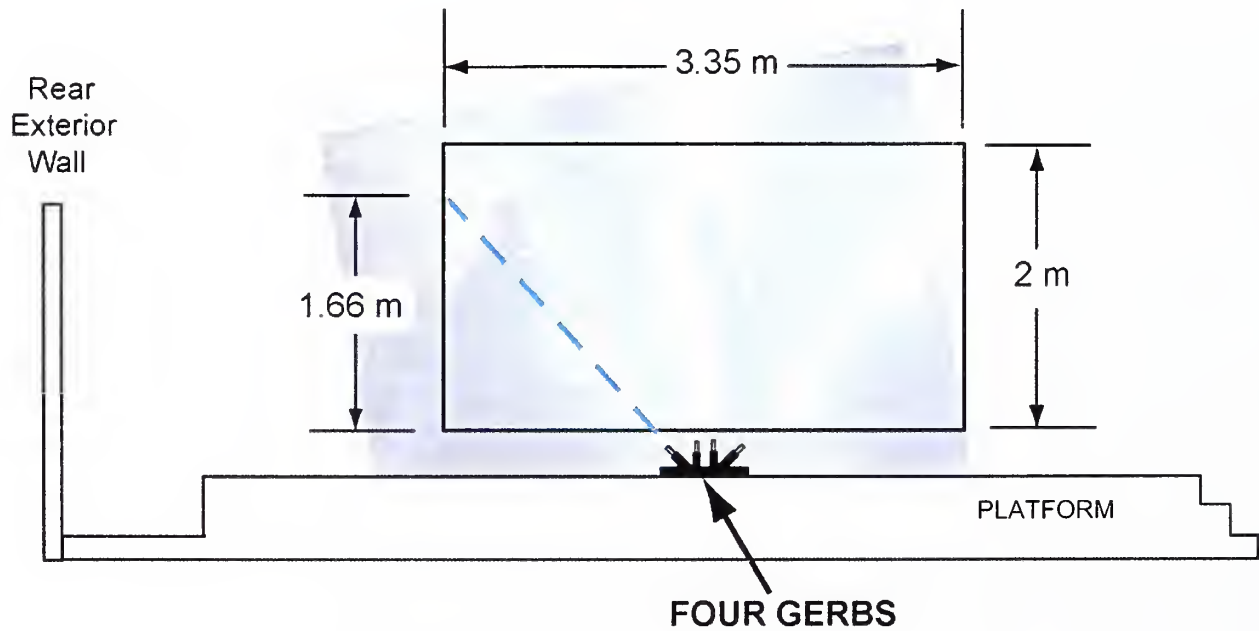
Figure 4-10. Pyrotechnics (15 x 15 gerbs) positioned on nightclub platform.
Video image copyright © 2003 TVL Broadcasting, Inc. All rights reserved.

The video recorded in the nightclub demonstrates that there were four gerbs positioned in front of the alcove. The two vertical gerbs were spaced about 0.1 m (4 in) apart and the two 45 degree gerbs were each positioned about 0.25 m (10 in) outside the vertical gerbs. This arrangement placed the tip of the 45 degree gerbs approximately 1.21 m (4 ft) from each of the side walls of the alcove. The spray of hot sparks would have impinged on a foam covered wall from about that distance.

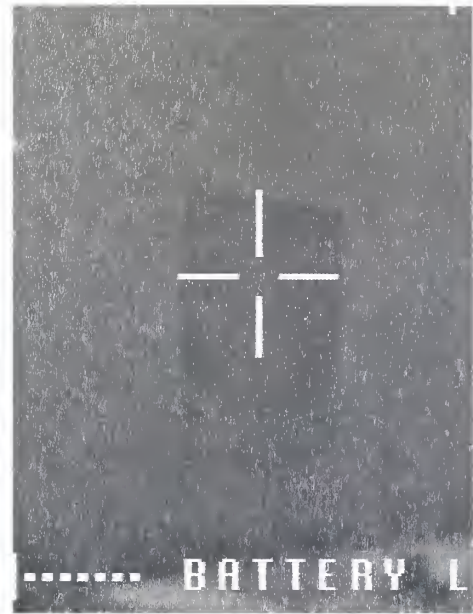
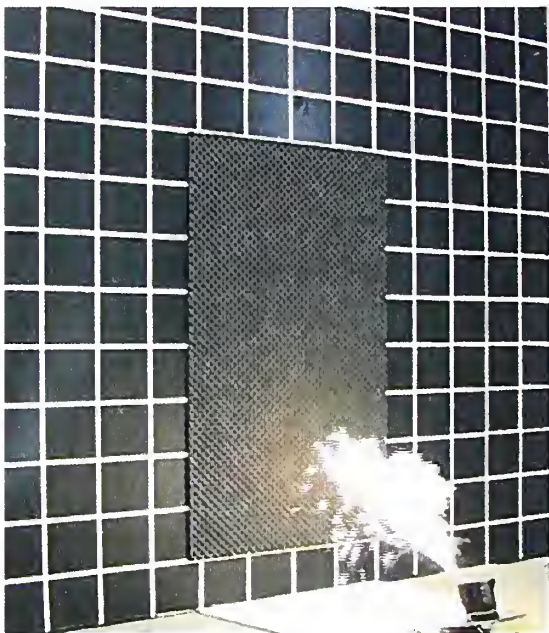
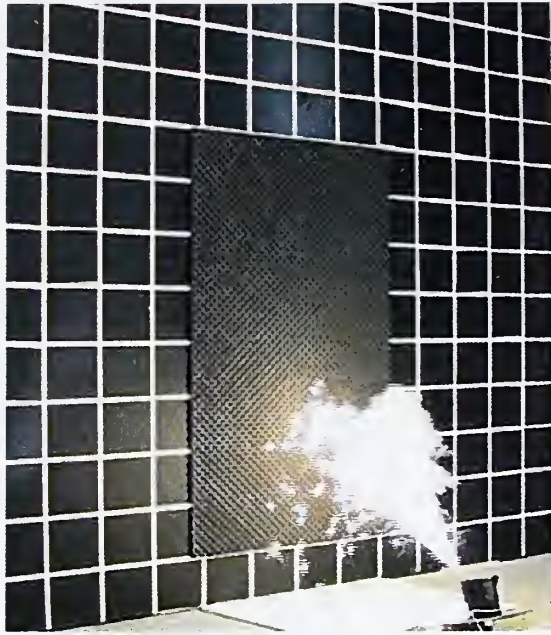
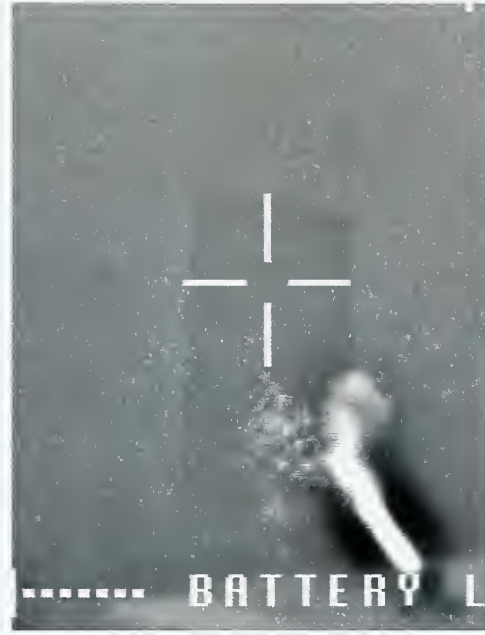
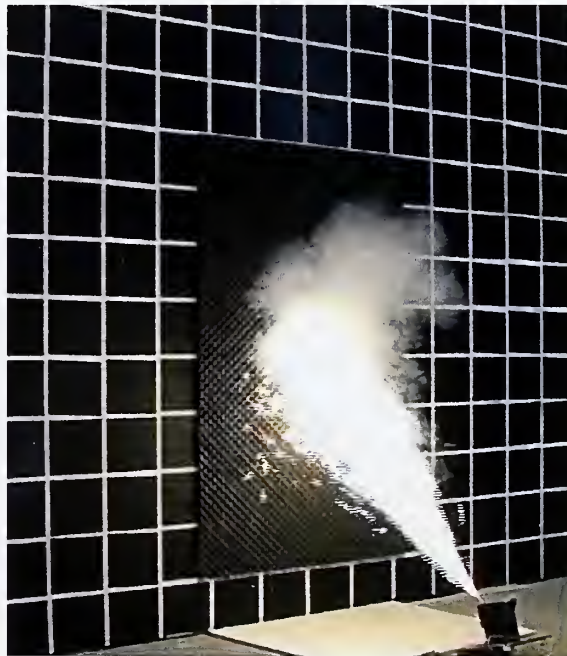
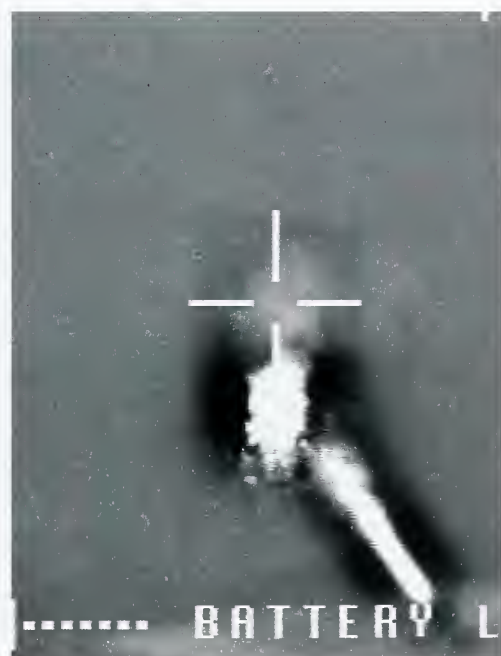
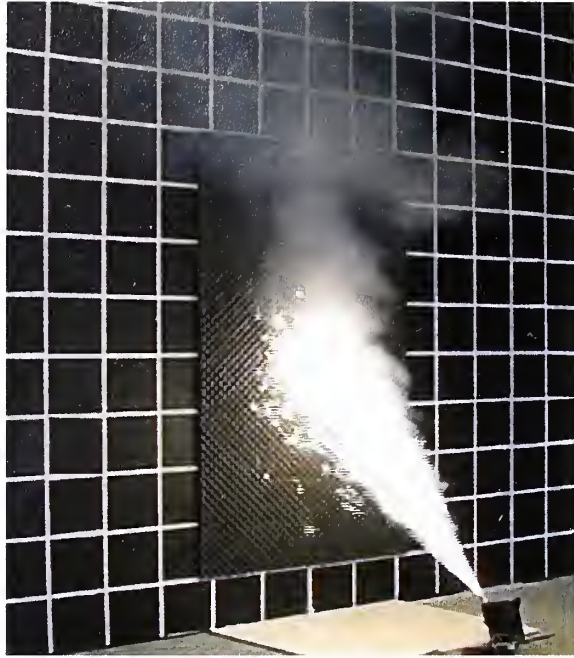
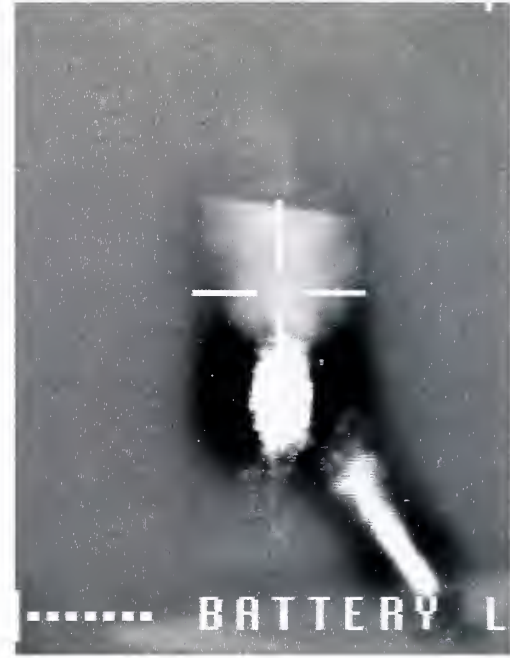
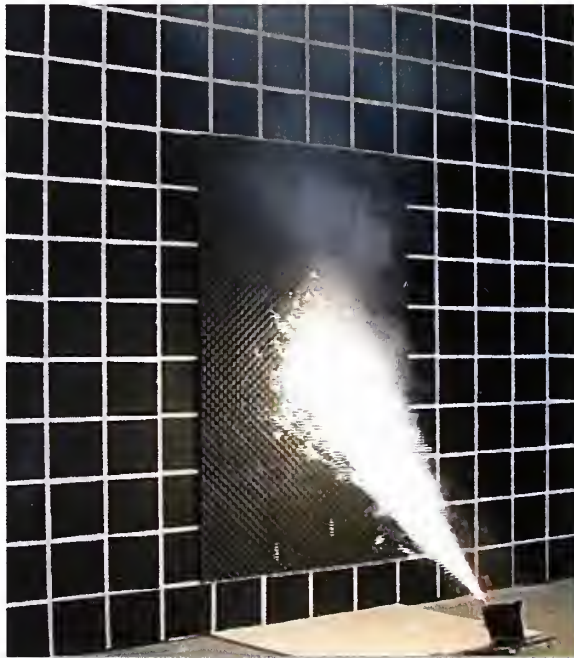
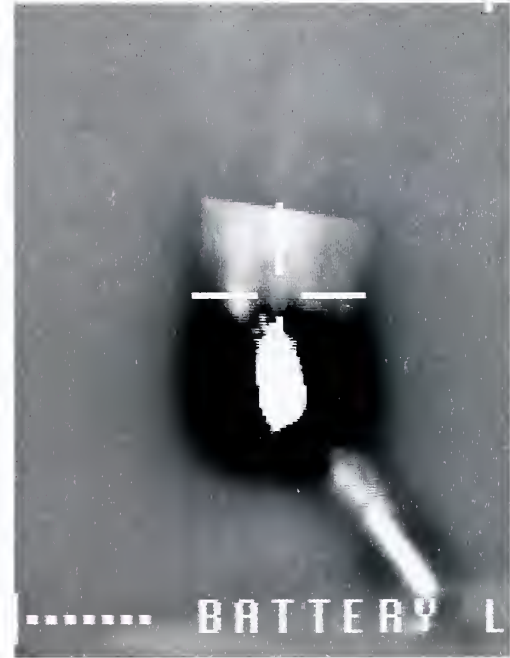
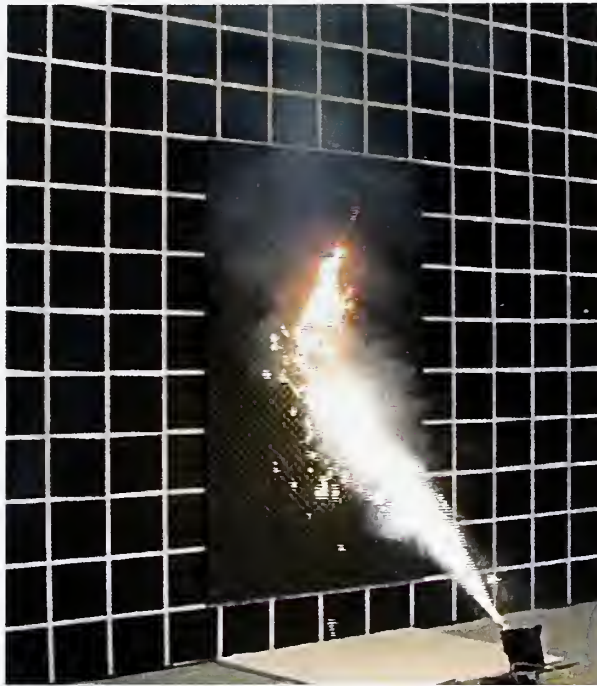
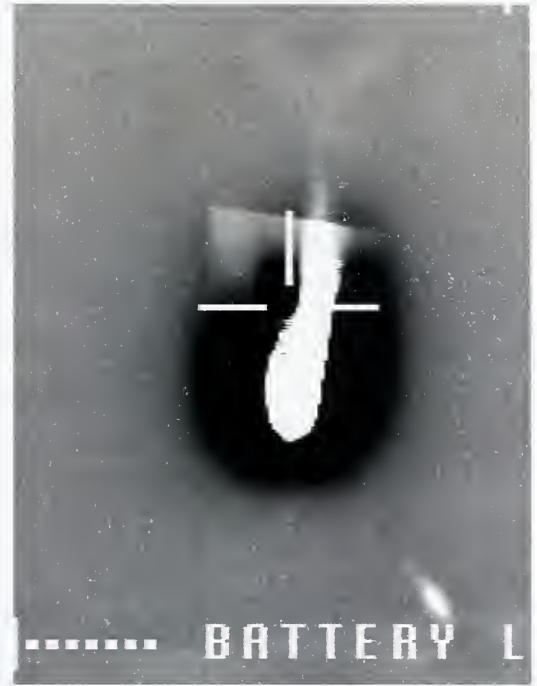
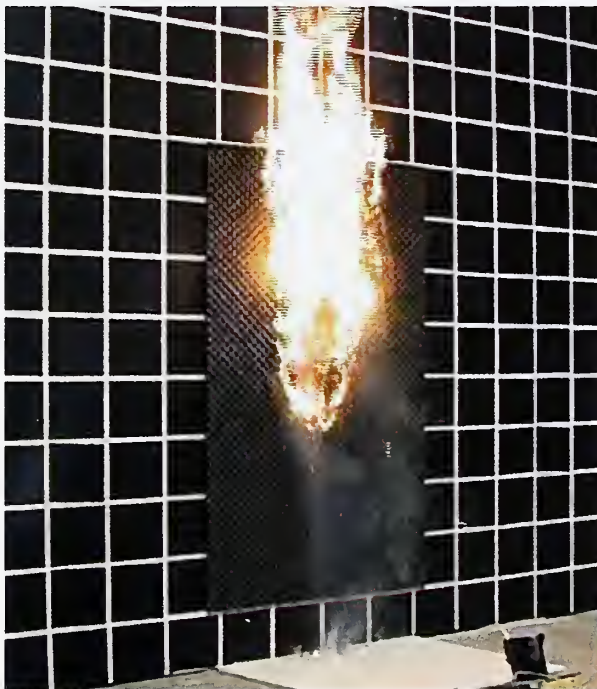
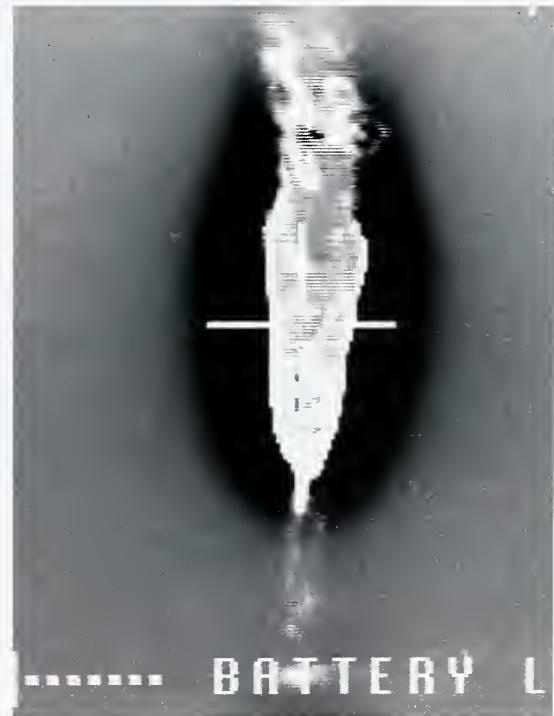
Still images were captured from the video recorded by the standard video and IR camera. For gerbs that were positioned at 45 degrees in a plane parallel to the wall, pairs of visible and infrared images are shown for times from 0 seconds to 30 seconds in Figure 4-13a through 4-13h. The visible images demonstrate that the gerb discharged a spray of white sparks for 15 seconds. The spray of hot sparks impacted the wall between 0.91 m (3 ft) and 1.5 m (5 ft) above the floor. Within 2 seconds after ignition, a thermal pattern (white area in IR image) developed on the wall. This area of increased temperature was oval in shape with a horizontal width of 0.3 m (1 ft) and a vertical dimension of 0.61 m (2ft). A similarly sized and positioned thermal pattern was also seen at 5 seconds into the discharge. The edges of the thermal pattern appeared fuzzy or diffuse. At 10 seconds after ignition, this thermal pattern had sharper edges and a black “haloing” appeared around the pattern. This haloing or shadowing has been observed under laboratory conditions in the presence of a significant thermal gradient. BST detectors measure relative levels of infrared radiation and are AC-coupled. The AC-coupling can cause a "black halo" or shadowing effect that increases as the relative radiation difference between an object and its surroundings increases unless a DC restoration process is included in the signal output circuitry. This would be consistent with the foam burning before $t = 10$ seconds. Although not clearly seen in the standard video camera, flames were observed on the right hand side of the hot spark pattern at 9 seconds. By 15 seconds a well defined and hot thermal plume was observed in the IR image. Gas temperatures are plotted versus time in Appendix F, Figs. F-16a and F-16b.

The width of the alcove in the nightclub was 3.0 m (10 ft) and the end of each gerbs was offset from the center of the opening by about one foot. The NIST tests demonstrated that a 15 x 15 gerb which was angled at 45 degrees and discharged against (and in a plane perpendicular to) a wall from a distance of 1.22 m (4 ft) could ignite a sheet of polyurethane foam in approximately 10 seconds. This is similar to the ignition sequence observed in the WPRI video.

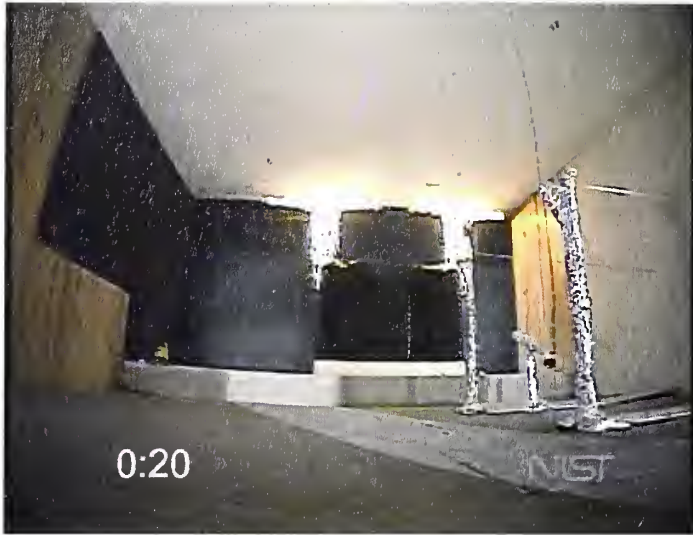
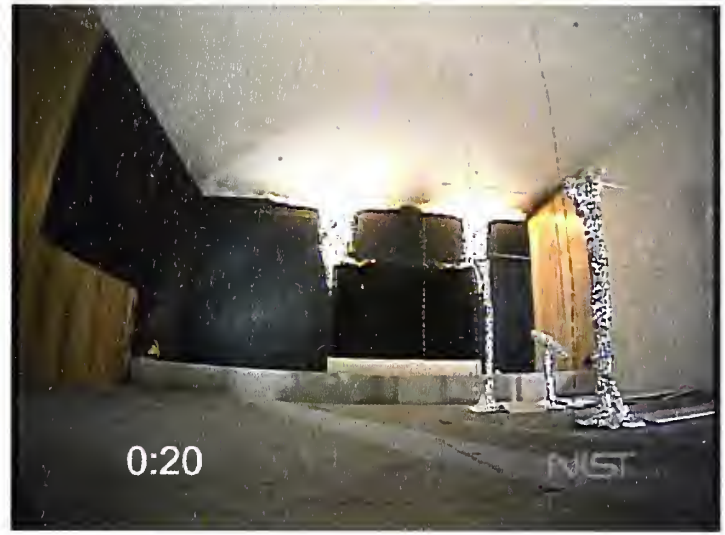
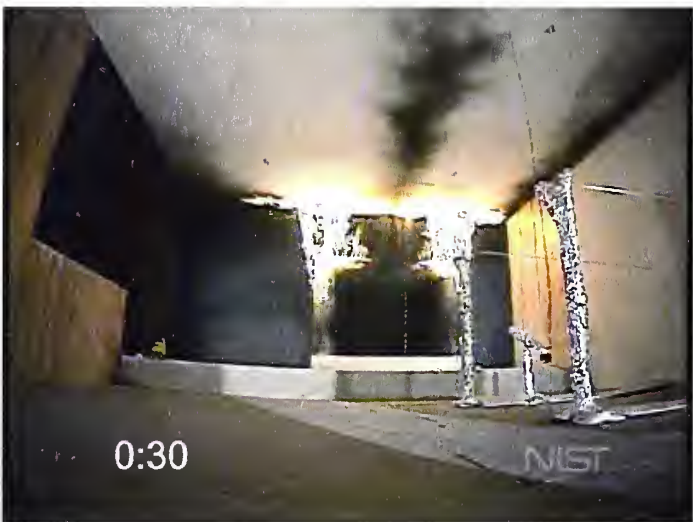
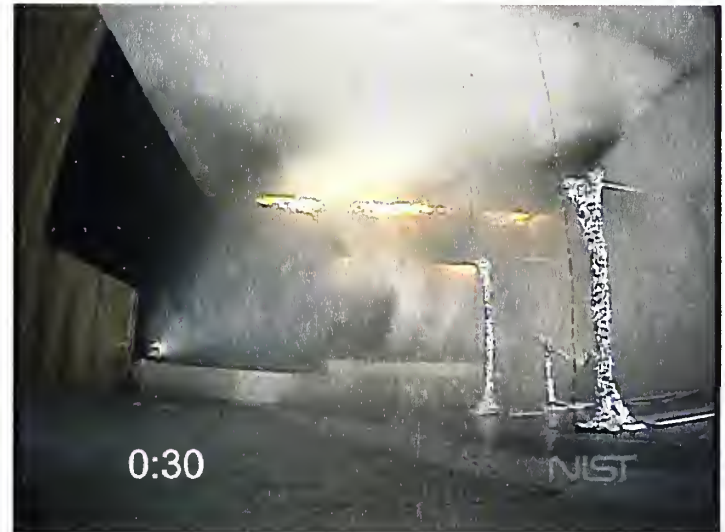
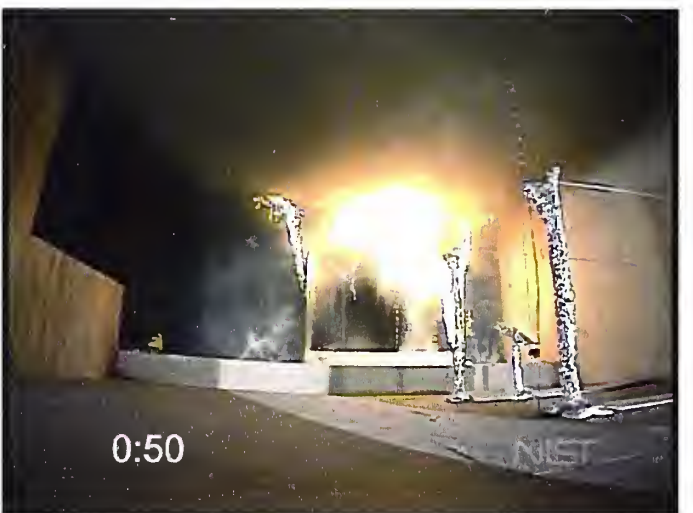
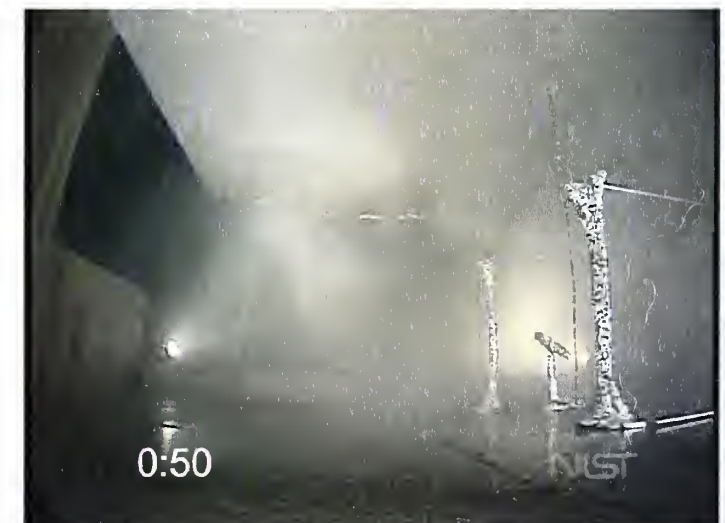
The succession of video frames on the left of Fig. 4-20 show how rapidly the fire spreads during the first 50 seconds, compared to how quickly the fire is controlled with sprinklers in the frames along the right. The first sprinkler activates on the right of the platform 24 seconds after ignition. By 30 seconds the sprinkler above the platform on the left and the sprinkler in the alcove have activated.

Figure 4-20. Still frames taken from video of full-scale mock-up experiments. Time after ignition is indicated in lower left of each frame. Left column: unsprinklered; right column: sprinklered (first head activates at 24 seconds)

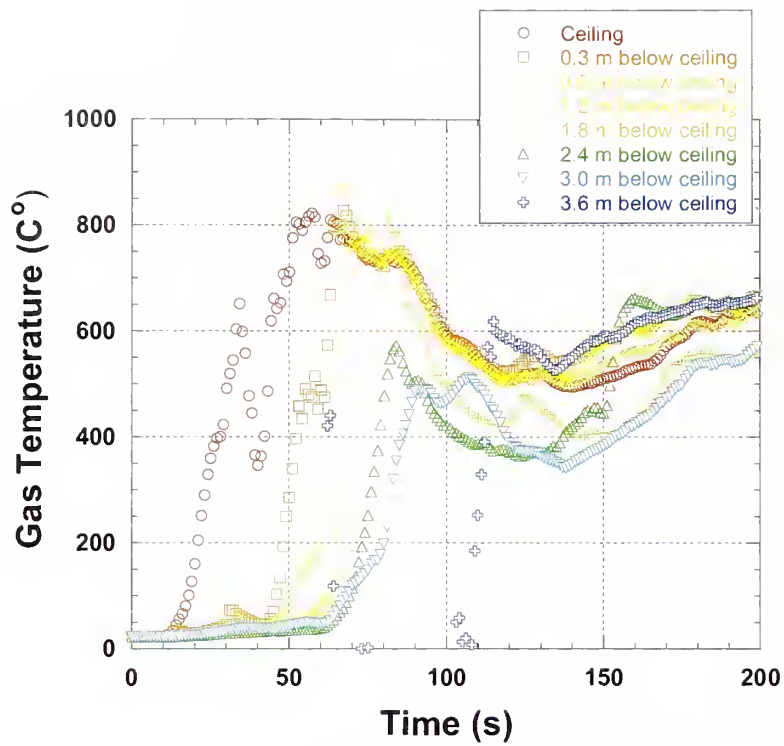
Figure 4-22. Temperatures versus Time for Unsprinklered Mockup Test. Thermocouples positioned on Platform (Location B) from ceiling to platform floor.

For the unsprinklered case, the temperature at the ceiling measured at location B (Fig. 4-22) began to increase within 10 seconds of ignition and continued to increase to over 800 °C in approximately 50 seconds. In less than 60 seconds, the temperature exceeded 50 °C at 1.4 m (4.5 ft) above the floor (2.4 m below the ceiling). The hot gases began to form an upper layer and the layer began to descend; in just over 110 seconds, the temperature at the floor of the platform had increased to over 600 °C.

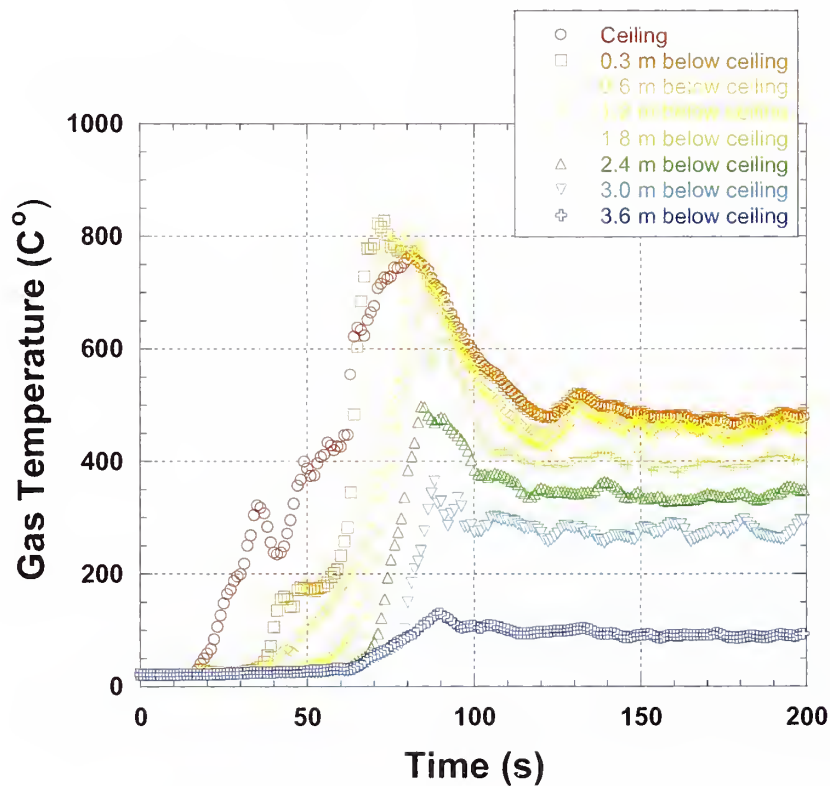
Figure 4-23. Temperatures versus Time for Unsprinklered Mockup Test. Thermocouples positioned on Main Floor (Location C) from ceiling to floor.

The thermocouple array at location C was installed 6.7 m from the foam covered platform wall, 3 m further away from the platform wall than the thermocouples at location B. The temperatures required about 15 seconds longer to begin increasing than those measured at location B, and required approximately 70 seconds to reach peak temperatures of 800 °C. From Fig. 4-23 one can see that the temperatures at 3.6 m below the ceiling did not begin to increase until 60 seconds after ignition and then the temperatures reached peak values of approximately 100 °C in 90 s. The temperatures at location C exceeded 50 °C at the 1.4 m (4.5 ft) above the floor (2.4 m below the ceiling) elevation in less than 70 seconds.

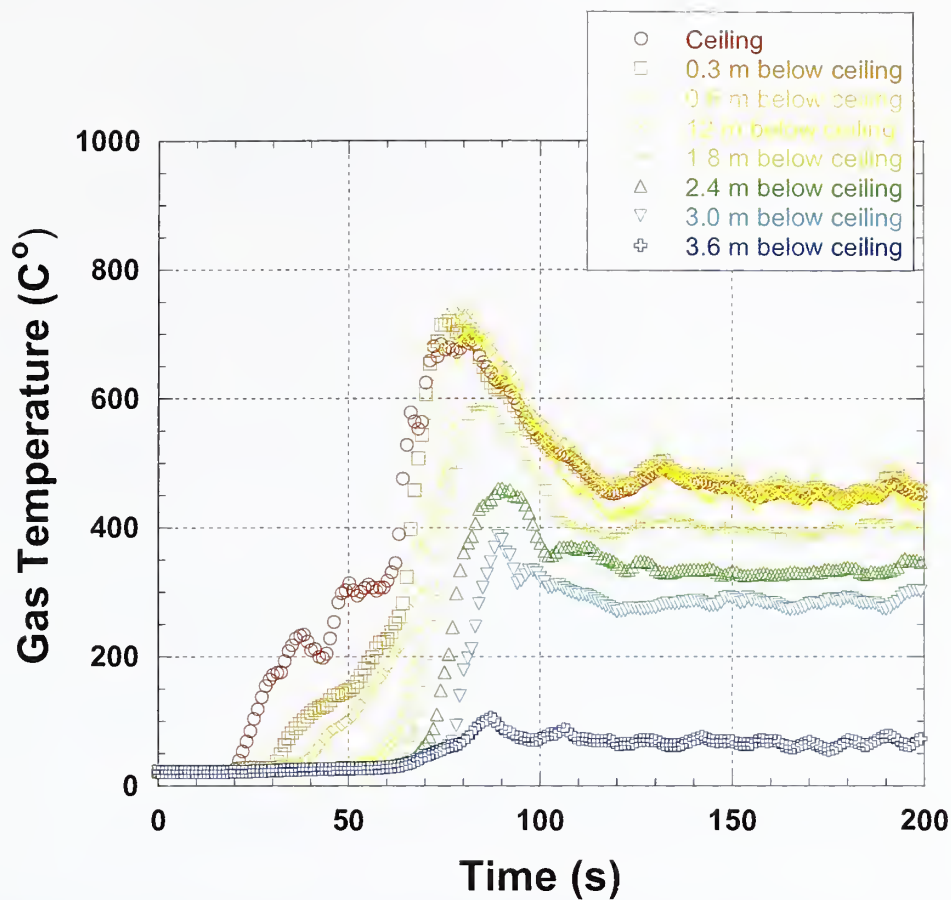
Figure 4-24. Temperatures versus Time for Unsprinklered Mockup Test. Thermocouples positioned on Main Floor (Location D) from ceiling to floor.

The thermocouple array at location D was installed 8.5 m from the foam covered platform wall, an additional 1.8 m further away from the platform wall than the thermocouples at location C. The temperatures began to rise in about 20 seconds (see Fig. 4-24), and required approximately 80 seconds to reach peak temperatures of 700 °C. The temperatures at 3.6 m below the ceiling did not begin to increase until 70 seconds after ignition and reached peak values of approximately 100 °C in 90 s. The temperatures near the floor at location D were about the same as the values recorded at the floor on the platform, Location C.

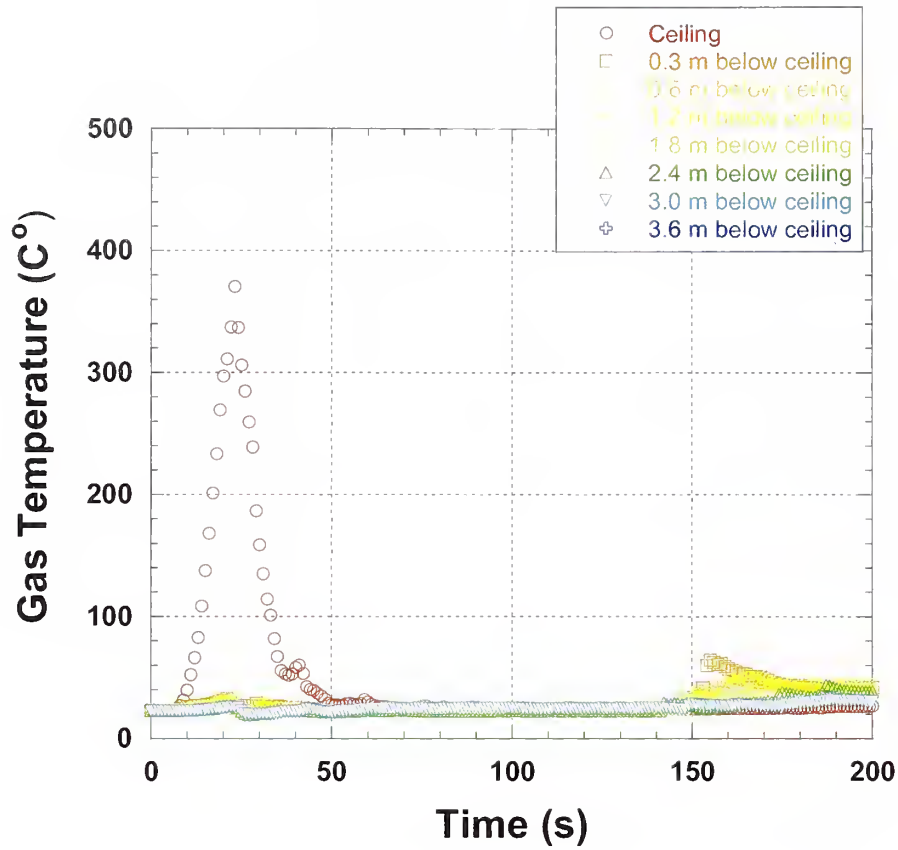
Figure 4-25. Temperatures versus Time for Sprinklered Mockup Test. Thermocouples positioned on Platform (Location B) from ceiling to platform floor.

For the sprinklered test burn, the ceiling thermocouple at location B (on the platform) recorded a peak temperature of 380 °C about 20 seconds after ignition, as can be seen in Fig. 4-25. When the sprinkler activated, the ceiling temperature quickly decreased, dropping to about 20 °C within 40 seconds of ignition. The activation of the sprinklers caused the other thermocouples at lower elevations to record near ambient temperatures throughout the test burn.

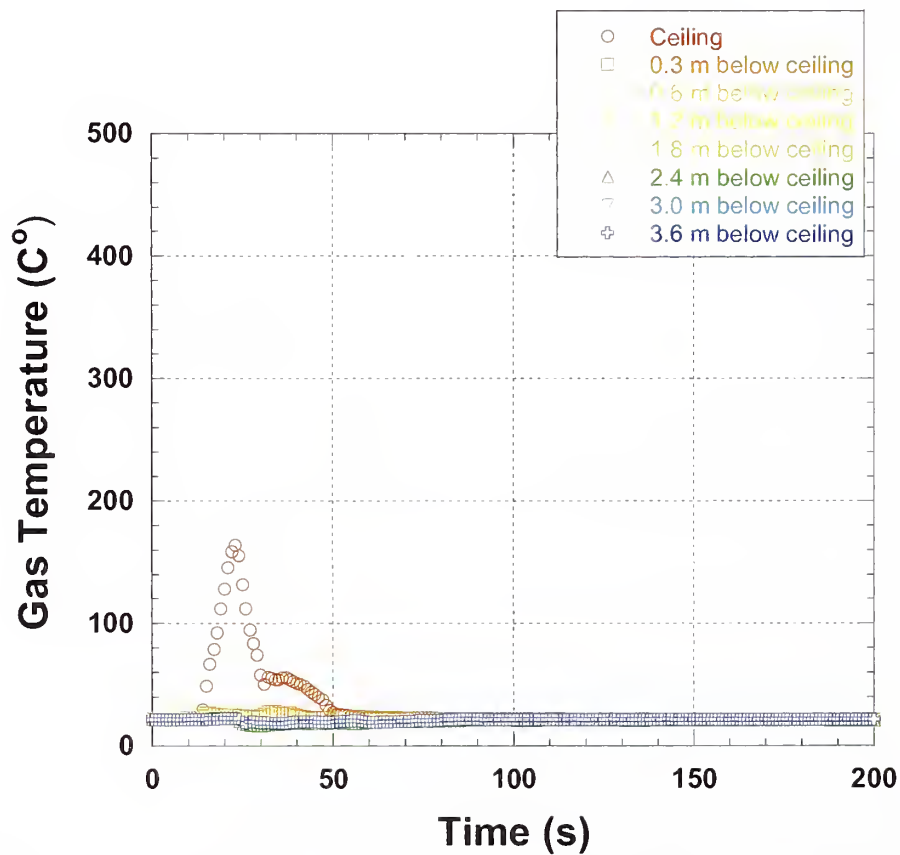
Figure 4- 26. Temperatures versus Time for Sprinklered Mockup Test. Thermocouples positioned on Main Floor (Location C) from ceiling to floor.

At location C (Fig. 4-26), the ceiling temperatures reached a peak temperature of 170 °C in about 20 seconds and declined to near ambient temperatures within 60 seconds. For location D (Fig. 4-27), the ceiling temperatures reached a peak temperature of 130 °C in about 20 seconds and declined to near ambient temperatures within 60 seconds. Thermocouples at lower elevations for both locations appeared to remain at near ambient temperatures throughout the test.

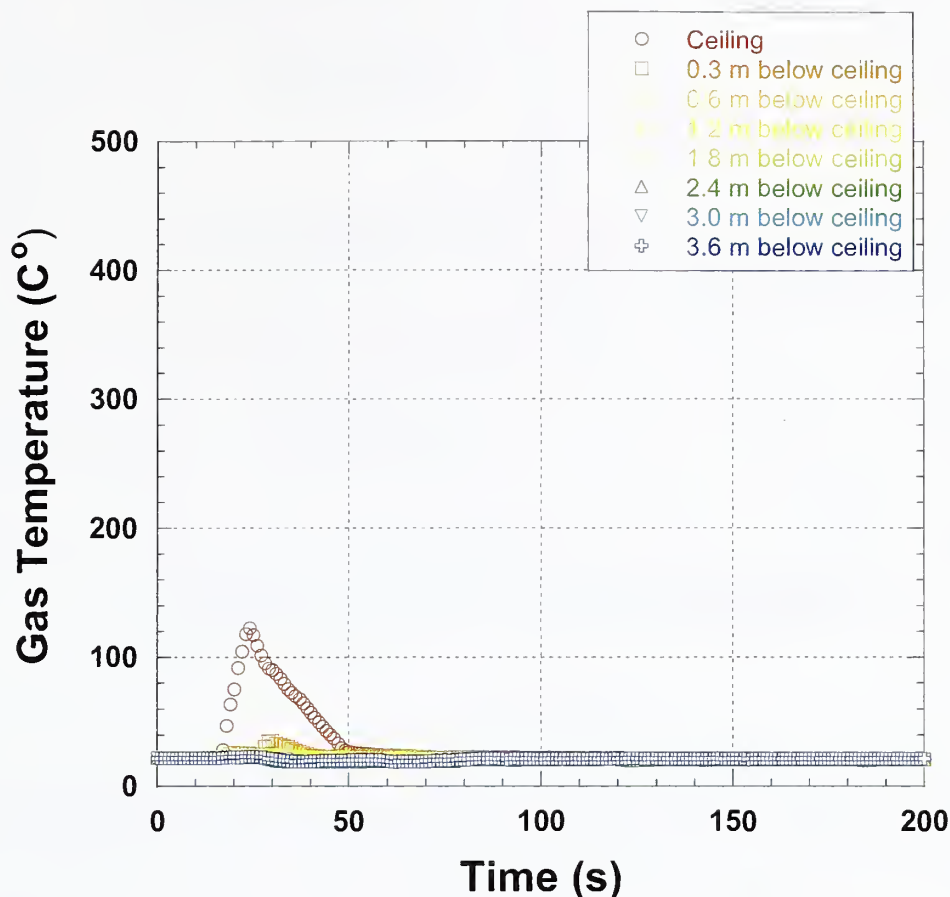
Figure 4-27. Temperatures versus Time for Sprinklered Mockup Test. Thermocouples positioned on Main Floor (Location D) from ceiling to floor.

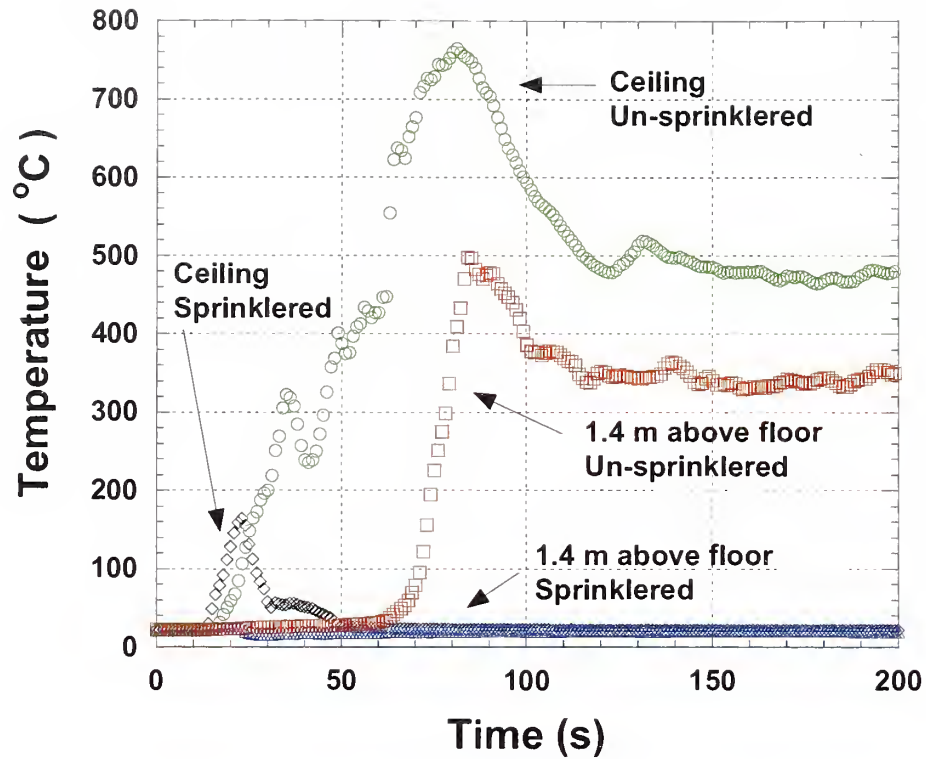
The comparison between the temperatures at the ceiling and 1.4 m above the floor for the sprinklered and unsprinklered experimental data is striking, as demonstrated in Fig. 4-28a for location C and Fig. 4-28b for location D. At 25 seconds, the temperatures at the ceiling were about 175 °C at location C and 125 °C at location D for both experiments, indicative of the fire being properly replicated up to the point when the sprinkler activated. During the next 25 seconds the temperatures throughout the compartment returned to close to ambient conditions in the sprinklered compartment. This compared to a continuing rapid rise in temperatures for the unsprinklered compartment, which reached ceiling temperatures in excess of 300 °C at 50 seconds, and peaks of 700 °C plus in the following 25 seconds. Peak temperatures of 400 °C to 500 °C were reached 1.4 m above the floor for the unsprinklered test; temperatures did not rise at all for the sprinklered compartment at this location.

Figure 4-28a. Temperatures versus Time for Unsprinklered and Sprinklered Mockup Test. Thermocouples positioned on Main Floor (Location C) at ceiling and 1.4 m (4.5 ft) above floor.
